Tabled Documents 18-5(2)

Government of Nunavut Request for Proposals

RFP # 2017-63

**Feasibility Study Rankin Inlet Water Infrastructure-Treatment
Rankin Inlet Nunavut**

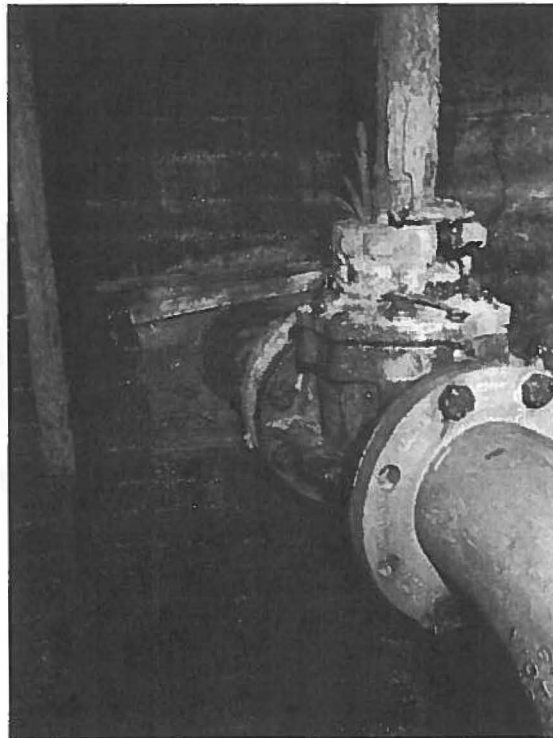
- Wet wells (storage tanks underneath the WLPH) are showing signs of significant deterioration (Figure 2):
 - Water pipes that feed into the wet well have significant corrosion and leaks

- Floor drain of WLPH leaks back into wet well
 - Up to one inch of corrosion in some areas of the wet well - a ladder has completely detached due to corrosion

Figure 2: Significant corrosion and deterioration of components in wet wells

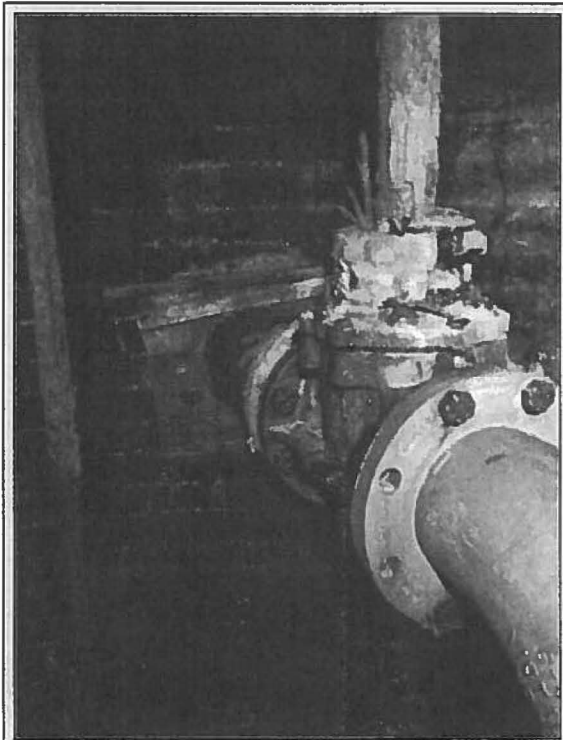
A corroding pipe is seen inside the bowels of the Williamson Lake Pump House. (GOVERNMENT OF NUNAVUT PHOTO)
